## Heritage Stone 3. Degradation Patterns of Stone Used in Historic Buildings in Brazil

A. G. Costa

Volume 43, Number 1, March 2016

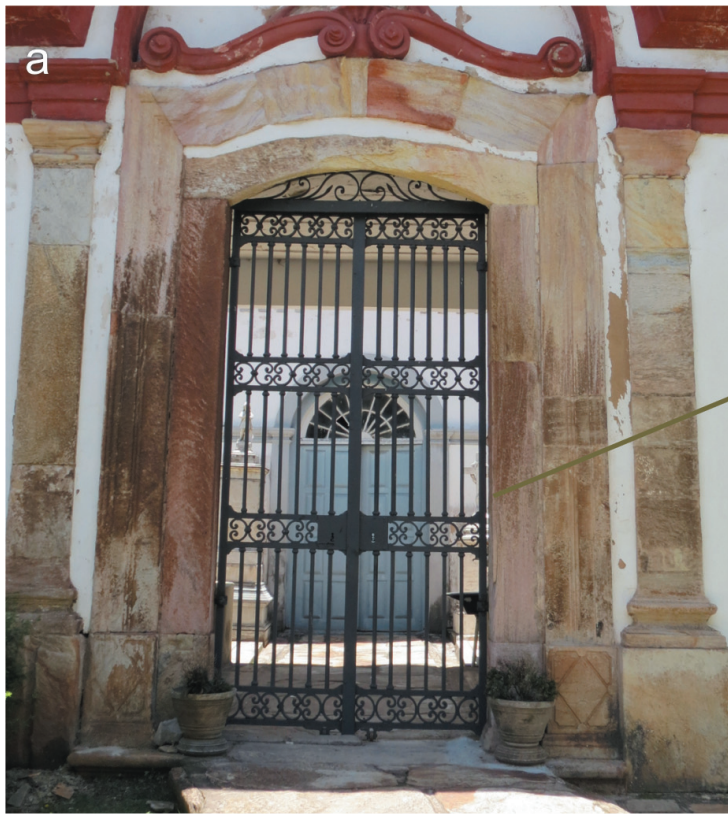
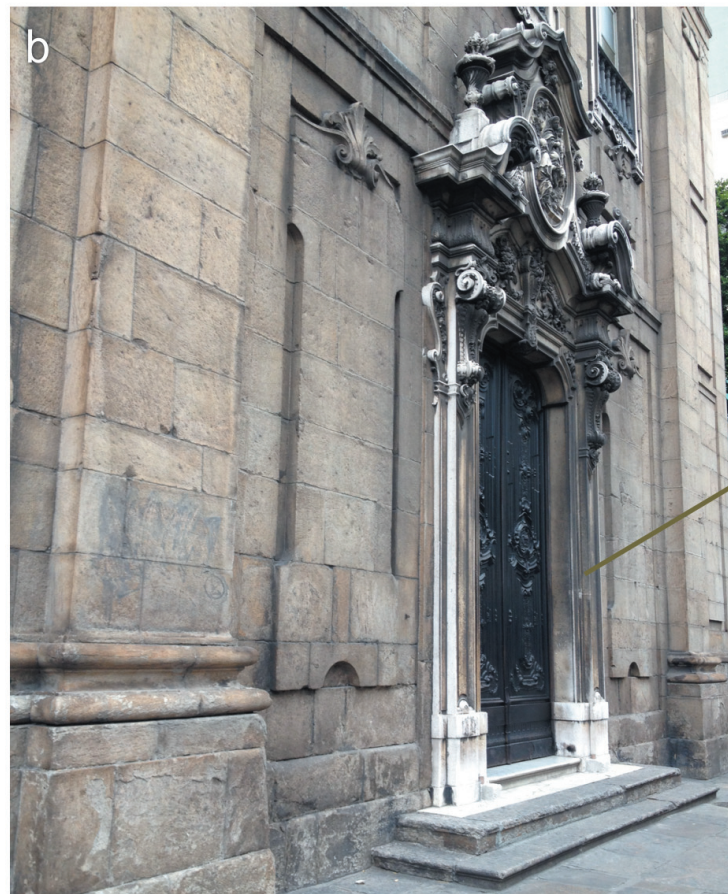
Some types of degradation were directly influenced by the textures and structures present in the stone employed. The presence or absence of a foliation, as well as variations in mineral content, are important factors. For example, where foliated rocks such as schist have been used, decay processes occur faster. Depending on the content of mica, planar structures may develop, and detachments ranging from delamination to exfoliation parallel to the stone structure demonstrate the strong influence of the rock's anisotropy.

Susceptibility is also associated with the type of rock-cutting method employed: blocks have been cut indiscriminately both parallel and perpendicular to rock foliation planes with concern for matching the type of cut with the requirements in each of those applications. Thus, in the parallel-cut blocks, where foliation planes lie vertically (Fig. 4), decay occurs rapidly as a result of surface delamination or exfoliation and separation of one or more layers. In some cases of detachment, separation involves submillimetric to centimetric elements such as flakes or scales parallel to the stone surface, although not following the stone structure. In such cases, as is observed at the external and flat wedges of the Capela de Nossa Senhora do Carmo (Chapel of Our Lady of Carmo) in Ouro Preto (Minas Gerais state), the process was identified as spalling (Fig. 5).

**Figure 4.** Detachment processes observed in parallel-cut blocks in which surface exfoliation is parallel to vertical foliation planes (schistosity) in a) a sericite-quartzite application in Ouro Preto, Minas Gerais, and b) a garnet gneiss application in the city of Rio de Janeiro.

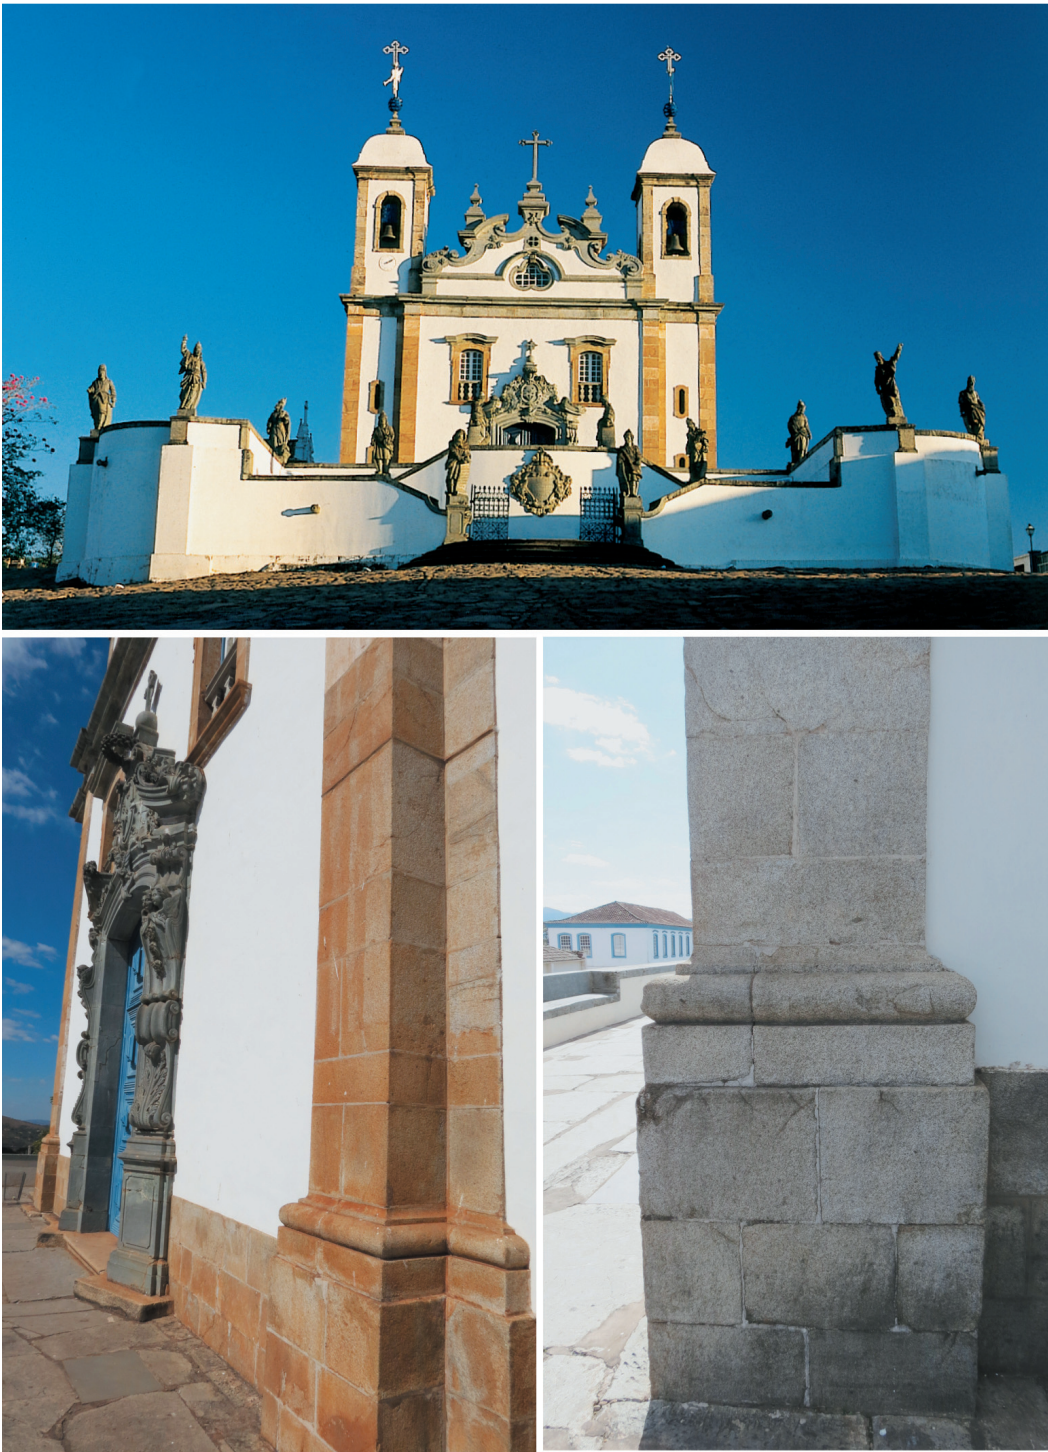
**Figure 7.** Example of patina formation (oxidation), deposition of particles, and biological colonization on the surface of granite blocks with whitish-grey original colour, on the frontispiece of the Congonhas Sanctuary of Bom Jesus church. The current brownish colour (patina) results from the position of these (outer) blocks facing the action of wind currents and variations in moisture content. In areas unaffected by such currents, the granite retains its original whitish-grey colour, although it is susceptible to intense biological colonization.
