# Heritage Stone 1. Repair and Maintenance of Natural Stone in Historical Structures

## The Potential Role of the IUGS Global Heritage Stone Initiative

Dolores Pereira and Brian R. Marker

Volume 43, Number 1, March 2016

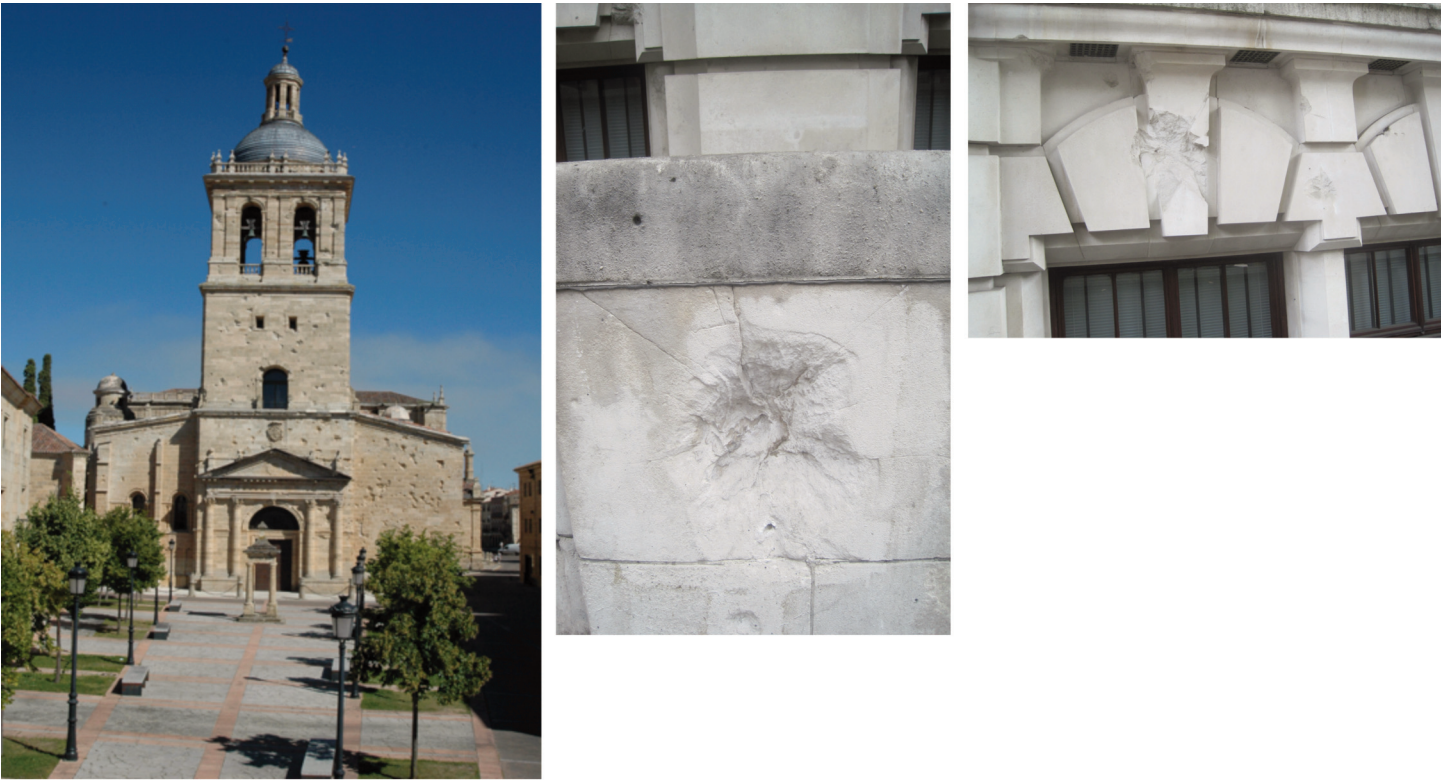
**Figure 1.** Examples of war damage: a) Cathedral in Ciudad Rodrigo (Salamanca, Spain) showing cannon ball impacts from the siege during the Peninsular War between French and Anglo-Portuguese and Spanish forces in the early 19<sup>th</sup> century. b) and c) parts of the façade of the Victoria and Albert Museum in London showing damage to the Portland Stone from casing fragments when bombs were dropped nearby. The damage was deliberately left unaltered when the façade was cleaned and repaired in 1985.

have endangered historical areas and sites for centuries, causing damage or, in some cases, complete destruction (Fig. 1). Recent and current political instability in some places, including some UNESCO World Heritage sites, is a matter for continuing concern but can only be solved by conflict resolution.

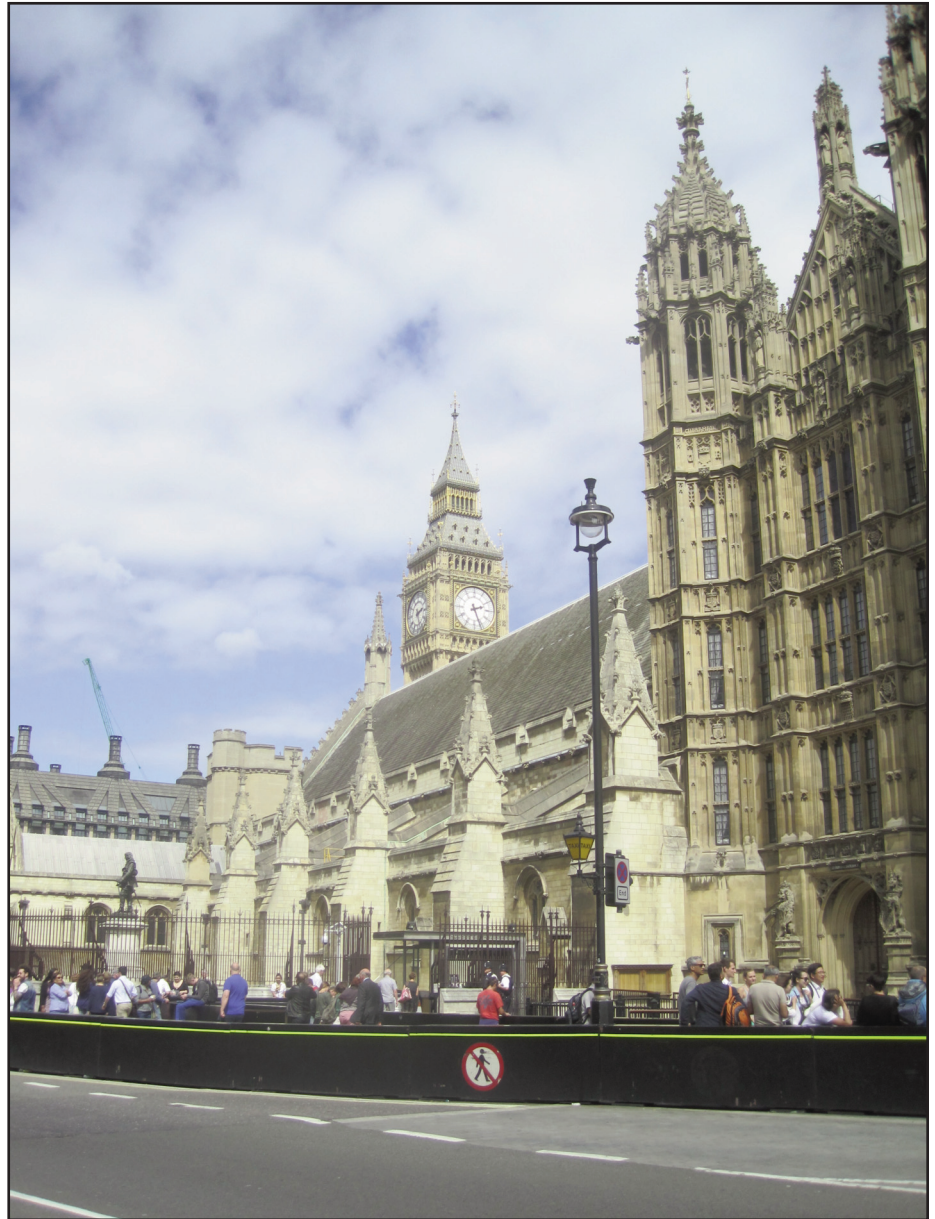
**Figure 2.** The Palace of Westminster showing pale-coloured Clipsham Stone from recent repairs, contrasting with Clipsham Stone from previous repairs and Anston Stone.

Original selection of stone was not always good, even in the case of some prestigious buildings. An example is the Palace of Westminster (often referred to as the Houses of Parliament) in London, UK, which has World Heritage status (Fig. 2). The original medieval buildings were largely destroyed by fire in 1837. A replacement was commissioned in the then popular Gothic Revival style and was completed in stages between 1847 and 1852 ([www.parliament.uk/about/living-heritage/building/palace/architecture/palacestructure/the-stonework](http://www.parliament.uk/about/living-heritage/building/palace/architecture/palacestructure/the-stonework)). The stone selected for the new building was *Anston Stone* (Cadeby Formation, late Permian), a dolomitic limestone from Nottinghamshire (Anonymous 2012a). A variety called ‘Mansfield White’ was selected because it could be easily carved and was available at a favourable price. However, it performed badly from the outset because of rapid weathering exacerbated by acidic rainfall and fog resulting from the predominant use of coal as a fuel in London until the mid-20<sup>th</sup> century and, subsequently, pollutants mainly from road traffic. By the 1930s it was necessary to begin replacing the Anston Stone with Clipsham Stone (Middle Jurassic), a pale ooidal to bioclastic limestone similar in colour to Mansfield White but with different physical properties (Anonymous 2012b). After suffering bomb damage in the 1940s that program was completed in the 1950s and thus most of the present façade is in Clipsham Stone. But, by the 1960s, damage was again evident, leading to further works from 1984 to 1991. However, in 2012 it was again necessary to begin extensive repair work, which is likely to last for many years but at a cost of several billion £GB. Although the Anston Stone had proved to be inadequate, significant amounts still remain in the structure. But as the Clipsham Stone has also deteriorated badly, this raises the issue of whether newly quarried Clipsham Stone should be used for partial compatibility, or whether a more durable stone might replace it even though that could affect the future performance of older parts of the structure. This illustrates the need to select good stone at the outset, taking into account the environmental conditions that it will be exposed to and the dilemma that can face the repairer after an alternative replacement stone has been used.

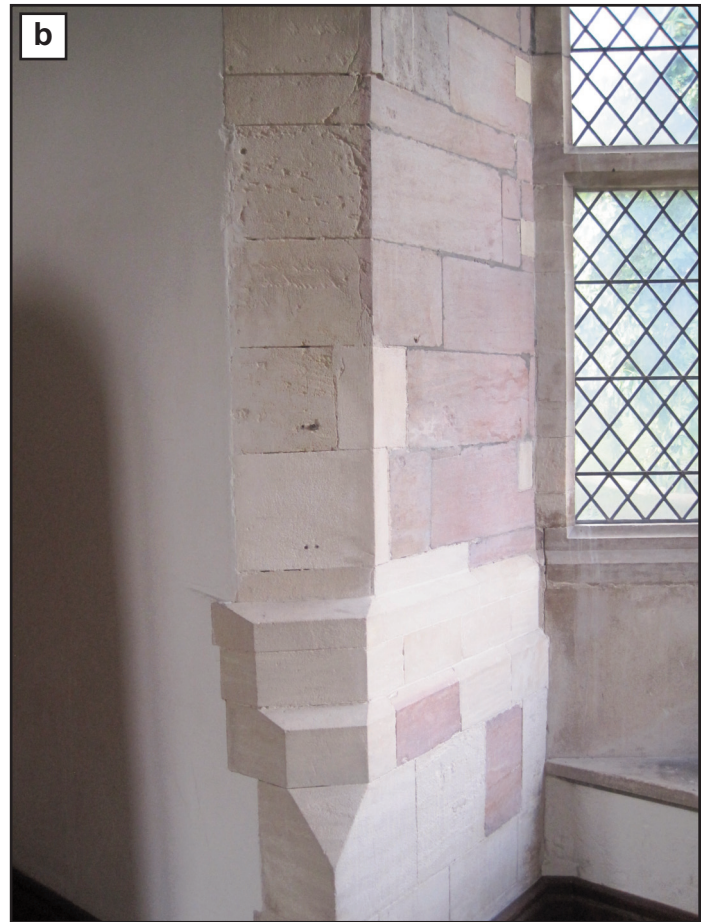
**Figure 4.** Examples of controversial or poor practices of stone usage. a) Queen Elizabeth II Courtyard, British Museum, London; b) contrasting replacement of stone in the interior of the Lincoln Cathedral, and c) replacement with stone of a different colour disrupting the original colour pattern in the exterior of the cathedral, Chipping Norton, Oxfordshire.

The British Museum was founded in 1753 as the world's first national public museum. The present building on the site was constructed in stages between the 1820s and 1850s using granite for the base courses and *Portland Stone* (Tithonian, Upper Jurassic) for the main body of the structure ([http://www.britishmuseum.org/about\\_us/the\\_museums\\_story](http://www.britishmuseum.org/about_us/the_museums_story)). In 2000, an internal courtyard was roofed over to form the Queen Elizabeth II Great Court, expanding visitor space by some 40%. The original Ionic portico of the courtyard had been demolished in the late 19<sup>th</sup> century. It was to be replaced (Fig. 4a) and the specification stated that the work should use 'stone from Portland.' In the event, Middle Jurassic stone imported from France (via Portland) was used, causing a major controversy in which some people considered that the stone was inappropriate while others praised the major architectural achievement ([www.theguardian.com/the\\_observor/2000/nov/12/2](http://www.theguardian.com/the_observor/2000/nov/12/2)). The colour and texture do not match and, since this part of the building is sheltered from weathering, the contrast is unlikely to decrease over time. This illustrates the importance of precise specification of stone but also raises the question of whether some changes should be allowed for architectural reasons.

rent repair and maintenance work employs appropriate stone but the building shows evidence of 19<sup>th</sup> and early 20<sup>th</sup> century interior work that is aesthetically unpleasing. Parts of the interior walling were originally built with red sandstone (Triassic) but some repairs were made with white limestone (Lincolnshire Limestone; Bajocian, Middle Jurassic) (Ashton 1980), of a type used extensively elsewhere in the cathedral. This resulted in an irregular patchwork of contrasting colours (Fig. 4b) that some consider undesirable.

Many buildings in the town of Chipping Norton date from the 18<sup>th</sup> century and were constructed mainly with *Hornton Stone* (bioclastic ferruginous limestone; Pleinsbachian–Toarcian, Lower Jurassic). This stone is susceptible to spalling. Chipping Norton Limestone (oolitic limestone; Bajocian, Middle Jurassic) (Horton and Edmonds 1987; Radley 2003, 2009) was used for detailing around windows in the structure illustrated in Figure 4c, providing a pleasing contrast. That colour pattern was disrupted by later repairs that used Middle Jurassic limestone in place of some of the darker Hornton Stone (Fig. 4c); the result is not likely to become visually compatible even after a period of weathering.

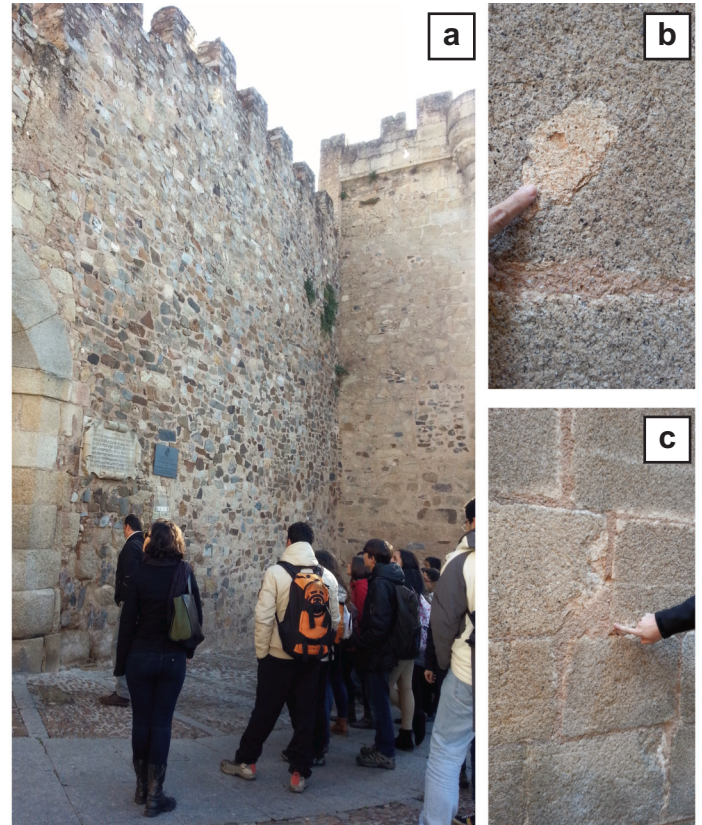
**Figure 6.** The Roman Wall around the World Heritage City of Cáceres, Spain, and use of mortar that contrasts markedly with the original colour of the granite forming the wall.

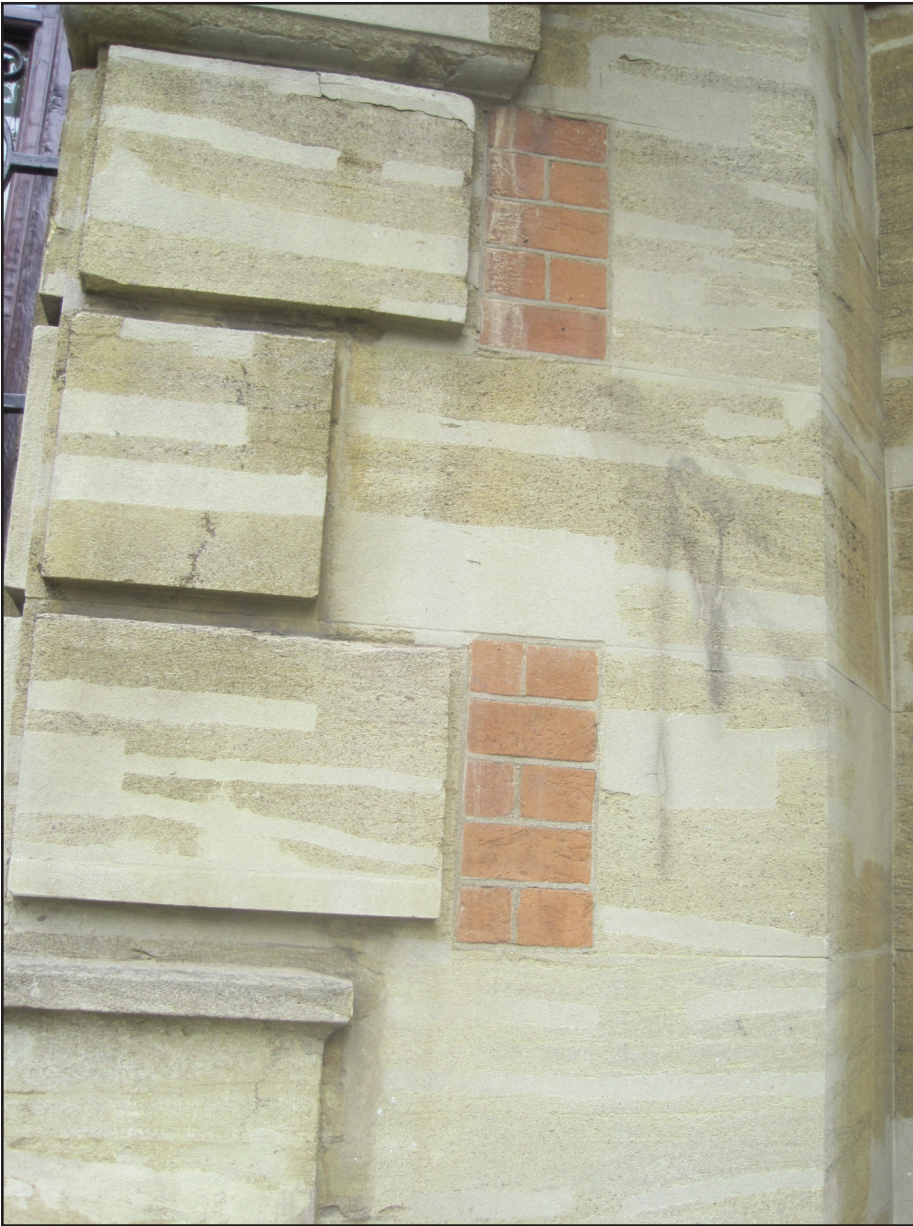
**Figure 7.** Part of the façade of a bank in Hampstead, London, showing inappropriate use of cement and brick in repairs to Douling Stone.

observed at the front of a bank in Hampstead, London. The façade was constructed with *Doulting Stone* from Avon (crinoidal biosparite; Bajocian, Middle Jurassic), which contains numerous large *Thalassinoides* burrows (Richardson 1915). The infilled burrows are more porous than the body of the rock, and weather more quickly. During ‘repair,’ the hollows associated with these burrows were simply cemented over but some red bricks were also used to replace seriously weathered stone blocks, producing a poor visual result (Fig. 7). While this is a minor building, these repairs detract from the late 19<sup>th</sup> century terrace of which it is a part.
