## Heritage Stone 3. Degradation Patterns of Stone Used in Historic Buildings in Brazil

A. G. Costa

Volume 43, Number 1, March 2016

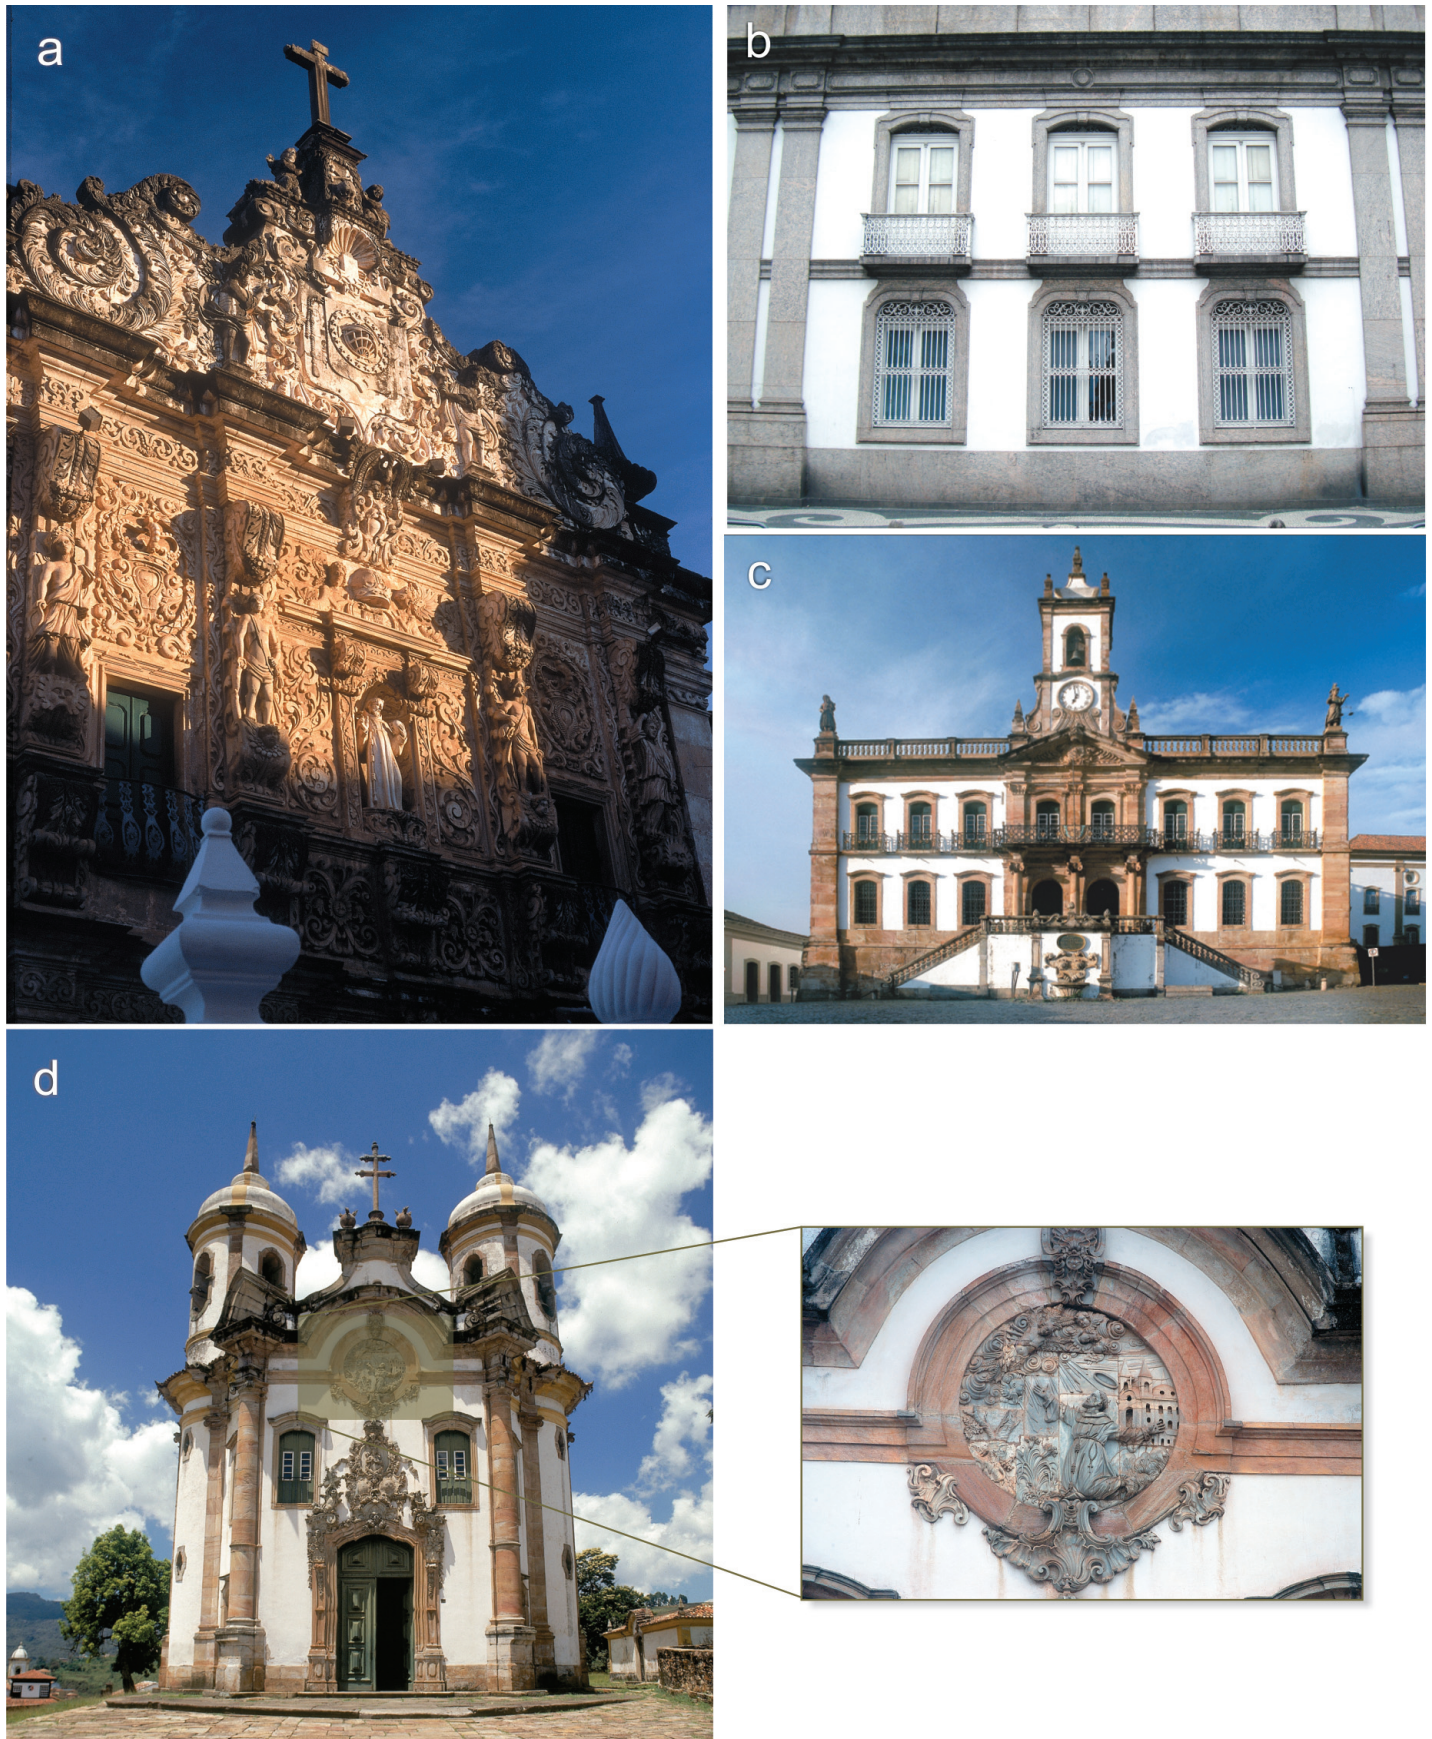
**Figure 2.** Selected uses of stone in the construction of Brazil's cultural built heritage. a) Limestone and sandstone in the frontispiece at the Chapel of The Third Order of Saint Francis, Salvador, Bahia; b) gneiss in a building in the city of Rio de Janeiro; c) quartzite in the old Casa de Câmara e Cadeia (Chamber and Prison House), located in Ouro Preto; and d) quartzite and steatite in the frontispiece of the Chapel of The Third Order of Saint Francis, Ouro Preto, Minas Gerais.
