## Building Stones of Canada's Federal Parliament Buildings

D. E. Lawrence

Lawrence, D. E. (2001). Building Stones of Canada's Federal Parliament Buildings. *Geoscience Canada*, 28(1), 13–30.

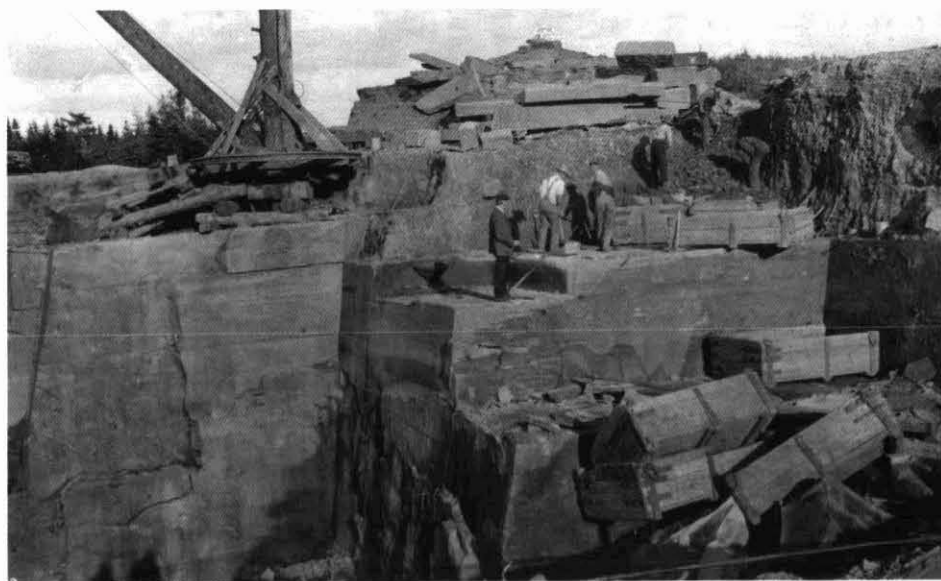
Figure 7 Quarrying sandstone at the Wallace Quarry, Nova Scotia. This stone was used in part as a replacement for Ohio Sandstone on the reconstructed Centre Block and Peace Tower. J. Keele, 1909, Geological Survey of Canada.

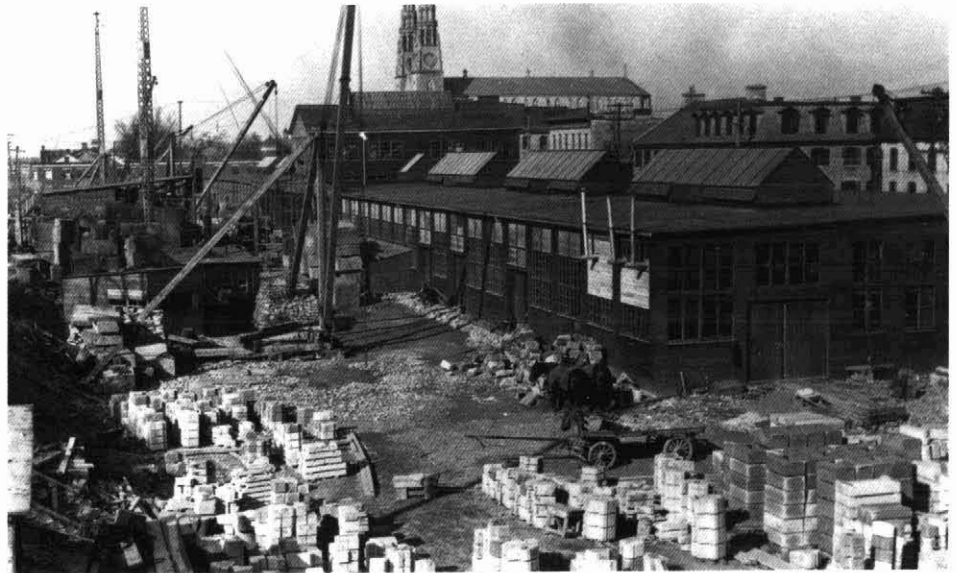
**Figure 11** The stone cutting shop on Sussex Drive, fall, 1916. Three derricks used to move the stone were located in the adjacent yard. This site is now occupied by the recently completed (2000) American Embassy. Notre Dame Basilica can be seen in the background. Samuel J. Jarvis collection, National Archives of Canada PA 24996.

300 men were employed, and in 1920 they were paid \$1.00/h compared to \$0.85/h for carpenters and plasterers and \$0.60/h for skilled labourers (Lyll and Sons, 1920). Special facilities along Sussex Street, east of the Rideau Canal, were constructed to cut and prepare the building stones (Fig. 11). According to John Pearson these facilities were the most complete and efficient of their kind in Canada for the finishing of stone and marble (Pearson, 1918). Over a period of 6 years, 16,000 tons of Nepean Sandstone for the exterior, at least 175,000 cubic feet of Tyndall Limestone for the interior, and considerable quantities of other sandstones, limestones, and marbles were handled in the workshops (Dubé, 1989).

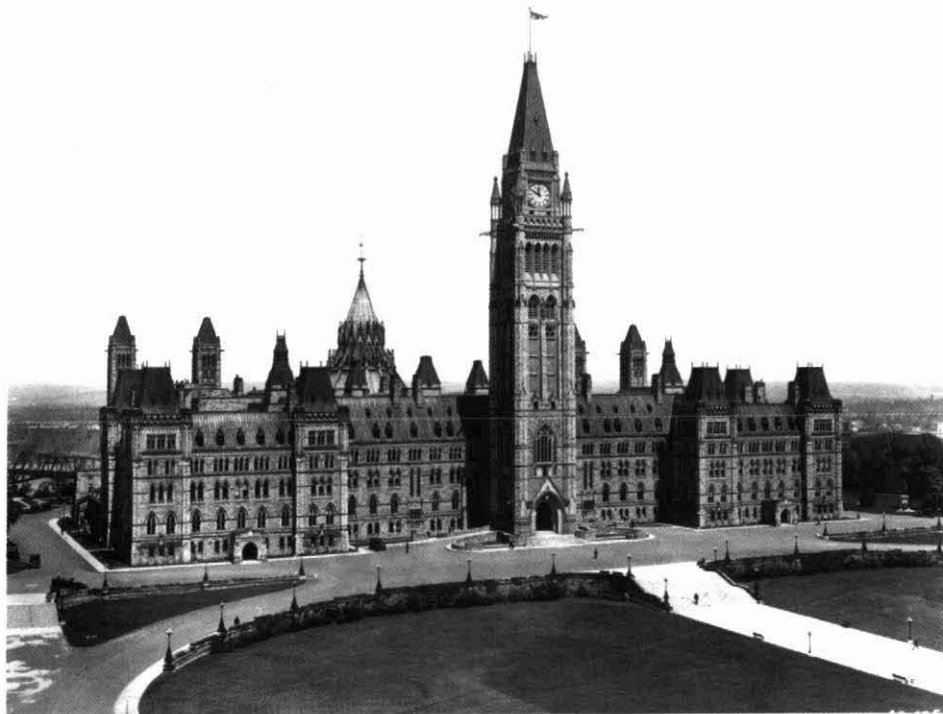
Figure 14 Canada's completed reconstructed Centre Block, circa 1953. Photo taken from the West Block. National Archives of Canada, C5856.

The Centre Block and the Peace Tower were finally completed after 12 turbulent years (Fig. 14). As noted by Gowans (Gowans, *in* Marsh, 1999, p. 1763), these buildings, along with the earlier East and West blocks, present one of Canada's most visually striking and historically remarkable building complexes.

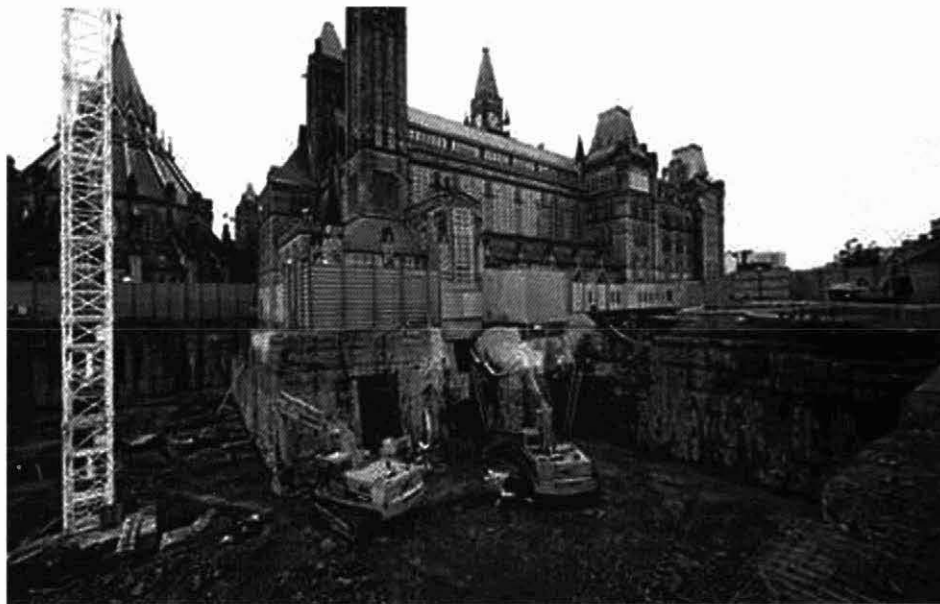
Figure 17 Excavation for the Centre Block Underground Services space (CBUS) involved the removal of about 30,000 m<sup>3</sup> of rock during a 3-month period in 1997. PWGSC 1997.

A 2-storey underground space approximately 50 x 40 m, called the Centre Block Underground Services (CBUS), was excavated on the north side of the Centre Block (Fig. 17). An innovative system of monitored and controlled blasting was carried out. This was done without disruption to existing heritage
