## The Restorations of the Westminster Abbey Chapter House

Steven H. Wander

Volume 4, Number 2, 1977

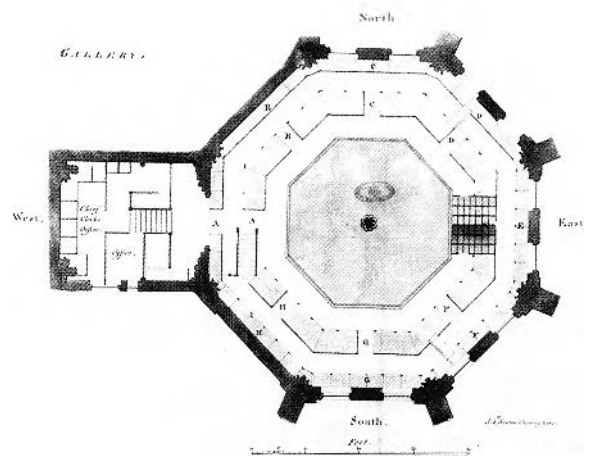
FIGURE 6. Chapter House, Westminster Abbey, Plan of the Gallery, 1807. London, Public Record Office, MPB 2/99/3.

in a view of the "Chief Clerk's Office" from the *General Inventory* (Fig. 8). Furthermore, a plan of the Chief Clerk's Office (Fig. 6), even though indicating other tracery mullions, shows no shafts on the west wall of the inner vestibule. If this arcading existed in 1807, it is difficult to explain why the draftsmen of the *General Inventory*, so sensitive to other tracery survivals, failed to record it.

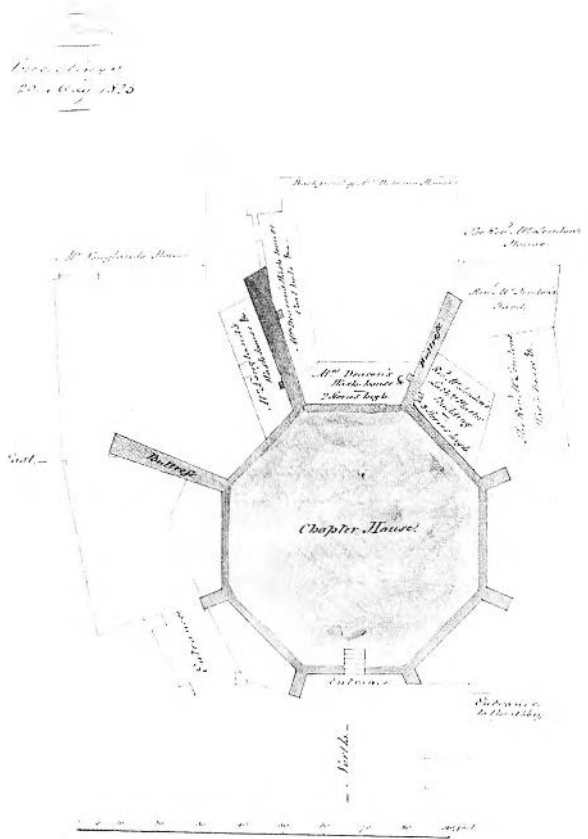
FIGURE 9. John Soane, *Chapter House Precinct Plan, Westminster Abbey*, 1825. London, Public Record Office, Works, 1/13, 348.

1819 by William Capon (Fig. 7), houses flanked the southern edge of the chapter house, and by the beginning of the eighteenth century outbuildings of the prebendal houses along the north walk of the Little Cloister already abutted against the walls and buttresses of the chapter house.<sup>31</sup> The plan of these outbuildings is included in a report by John Soane from 20 May 1825 (Fig. 9). Soane recognized that these outbuildings posed a serious threat of fire to the contents of the record office “from the materials with which some of them are constructed (*viz.* wood, and lath and plaster) and the manner in which the chimnies of most of them are situated with respect to the windowes of the chapter house.”<sup>32</sup> According to a letter of 31 December 1832 from Edward Blore, architect to Westminster Abbey, the most dangerous outbuildings were taken down in 1826;<sup>33</sup> but since

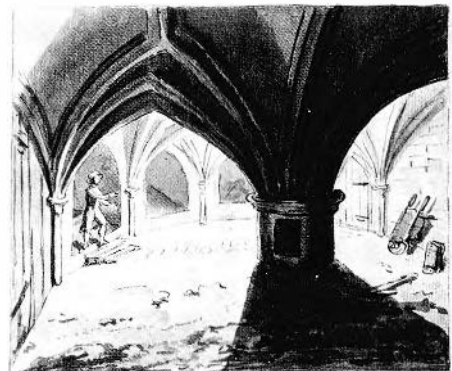
West view in the Undercroft of the Chapterhouse of Westminster Abbey.

FIGURE 12. William Capon (?), West view in the Undercroft of the Chapter house of Westminster Abbey. London, Westminster Abbey Library, Drawer 7, IIB, 7 (Photo: courtesy the Dean and Chapter of Westminster Abbey).

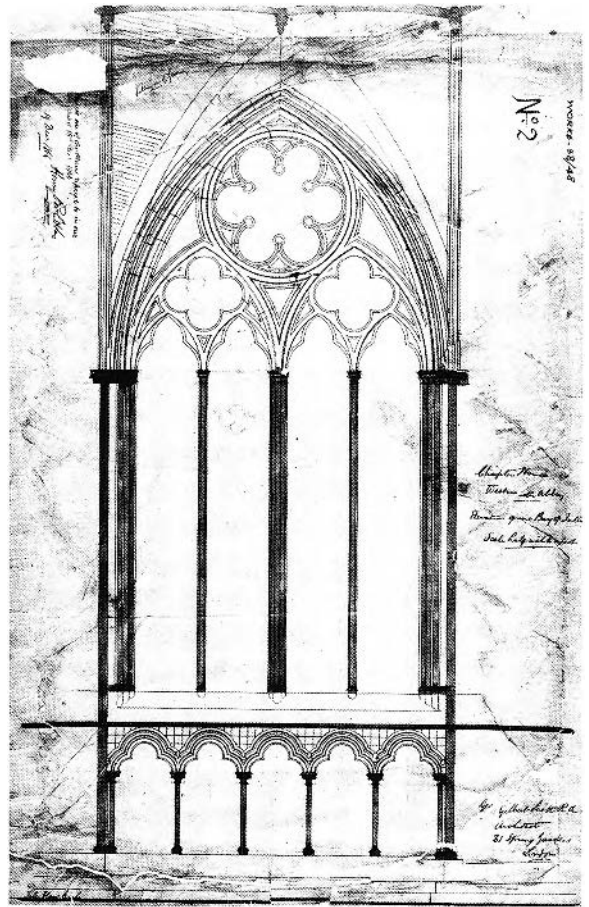
FIGURE 14. G.G. Scott, Chapter House, Westminster Abbey, Interior Elevation, 1866. London, Public Record Office, Works 38/48.

The second drawing (Fig. 14) shows the elevation of the other interior bays, the black Purbeck marble shafts being indicated with wash. Scott established the window design from original blind tracery which survived in the northwestern bay. In the section from the *General Inventory* (Fig. 4), blind tracery of four lights with quatrefoils appears clearly beyond the staircase while a portion of the sexfoil head peeks

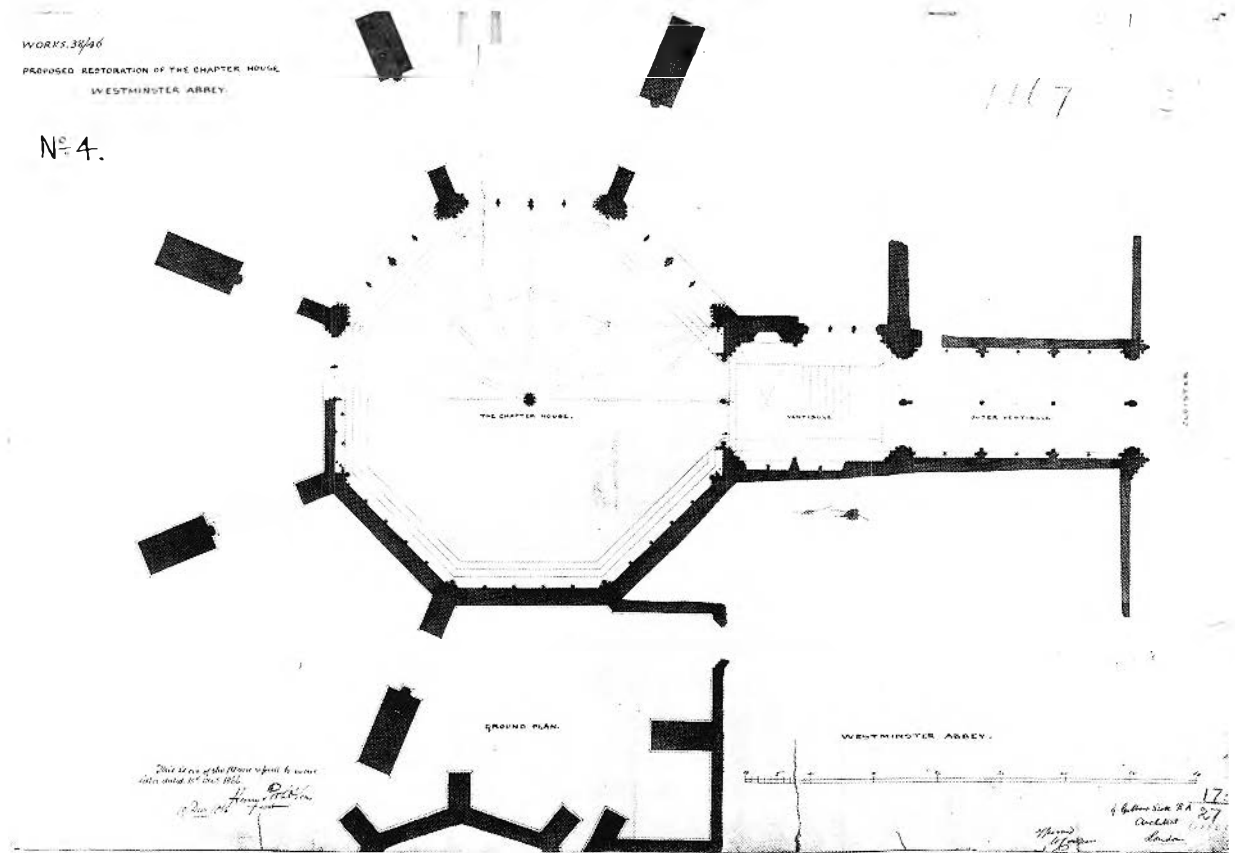
FIGURE 16. G.G. Scott, Chapter House, Westminster Abbey, Ground Plan, 1866. London, Public Record Office, Works 38/46.

The drawings numbered 3 and 4 show the longitudinal section and ground plan of the chapter house and vestibule (Figs. 15, 16). Scott had already removed the staircase leading to the chapter library from the northern aisle of the outer vestibule and rebuilt the destroyed vaults.<sup>44</sup> A view of 1782 shows that a portion of the wall arcade in the south aisle, along with the vaulting, had survived, and upon this Scott was able to base his restoration.<sup>45</sup> As shown in the section in the *General Inventory* (Fig. 4), original tracery with two pairs of twin lights and quatrefoils
