The Chancel of St. Paul's Anglican Church, Halifax, Nova Scotia: Form Follows Convenience?

J. Philip McAleer

Volume 17, Number 1, 1990

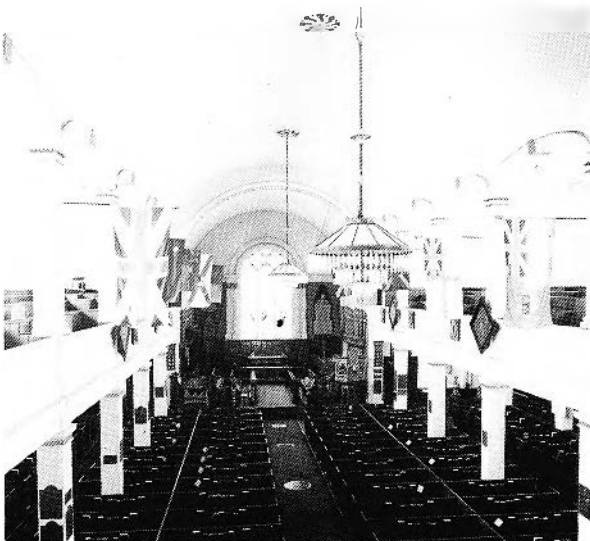
FIGURE 33. St. Paul's, Halifax. The interior as it appeared in 1987 (chancel of 1872) (Photo: T.U.N.S./P. Toman).
