## The Lesson of the Quebec Bridge

Wilfred G. Lockett

Volume 11, Number 2 (33), Fall–Winter–Autumn–Winter 1987

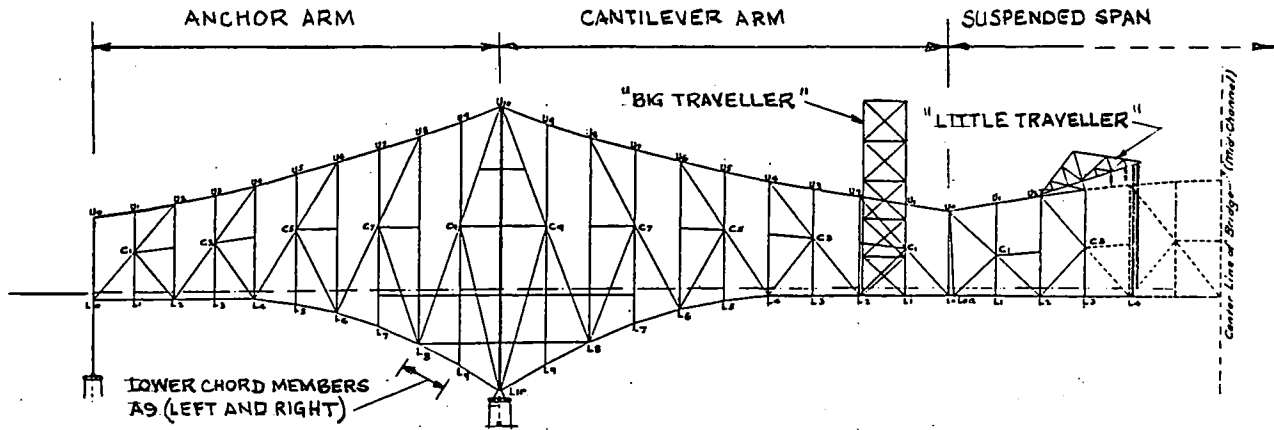
FIGURE 6

CONDITIONS ON AUGUST 29, 1907

By August, 1907, construction had reached the stage where the south cantilever had been completed and erection of the suspended span, jutting out from the end of the cantilever, was in hand. The 'big traveller,' a movable gantry used in the handling of components, was being dismantled in anticipation of transferring it to the north bank, and a 'little traveller' was in use for the work on the suspended span (see Figure 6).

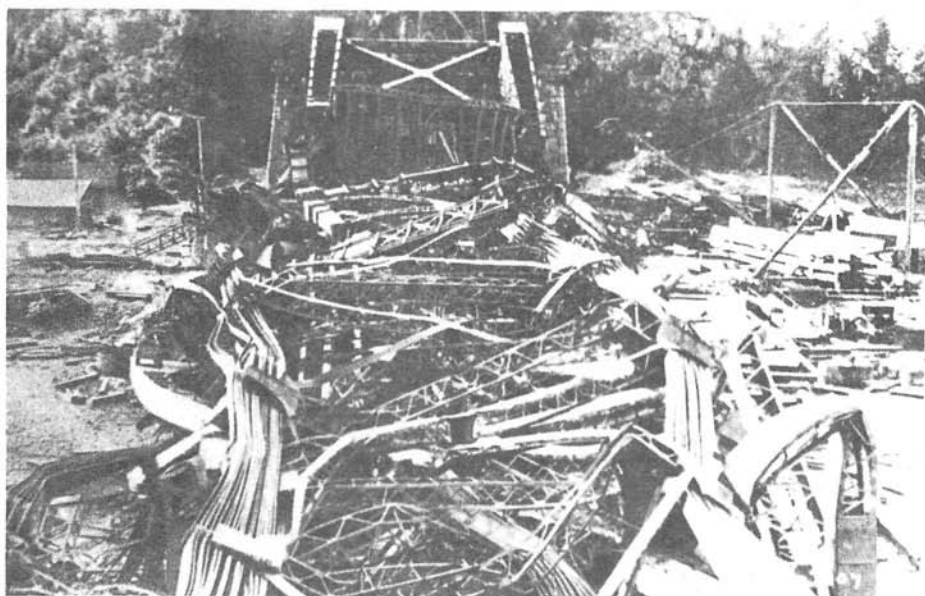
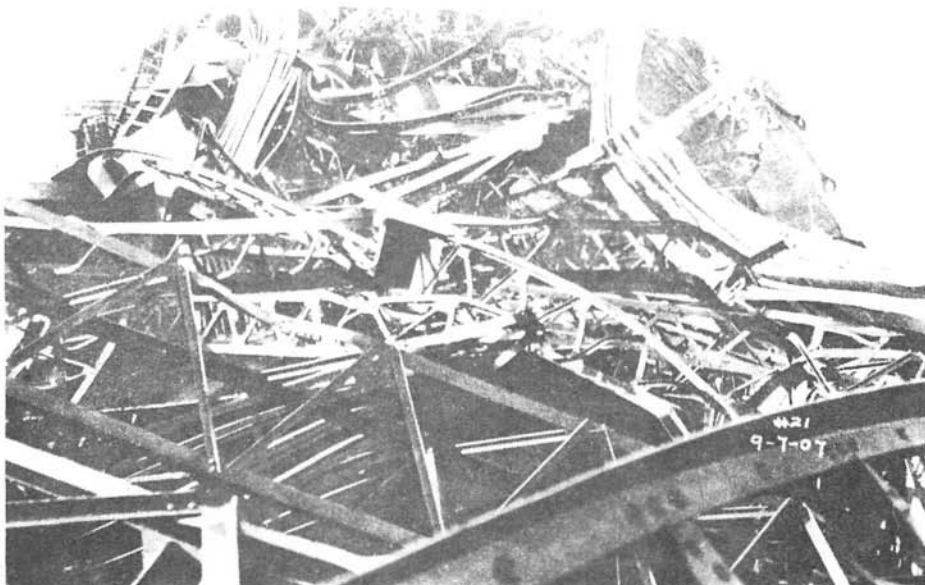
Figure 7(a) Wreckage, looking south [top]; 7(b) looking north

Cooper instructed McLure to discuss the problem with Deans. McLure's arrival in Phoenixville, at about 5.00 pm on Thursday, 29 August, coincided with the collapse into a tangled heap of the whole superstructure, taking the lives of 74 men, including Yenser and Birks. (Figures 7)
