## The Lesson of the Quebec Bridge

Wilfred G. Lockett

Lockett, W. G. (1987). The Lesson of the Quebec Bridge. *Scientia Canadensis*, 11(2), 63–89. <https://doi.org/10.7202/800254ar>

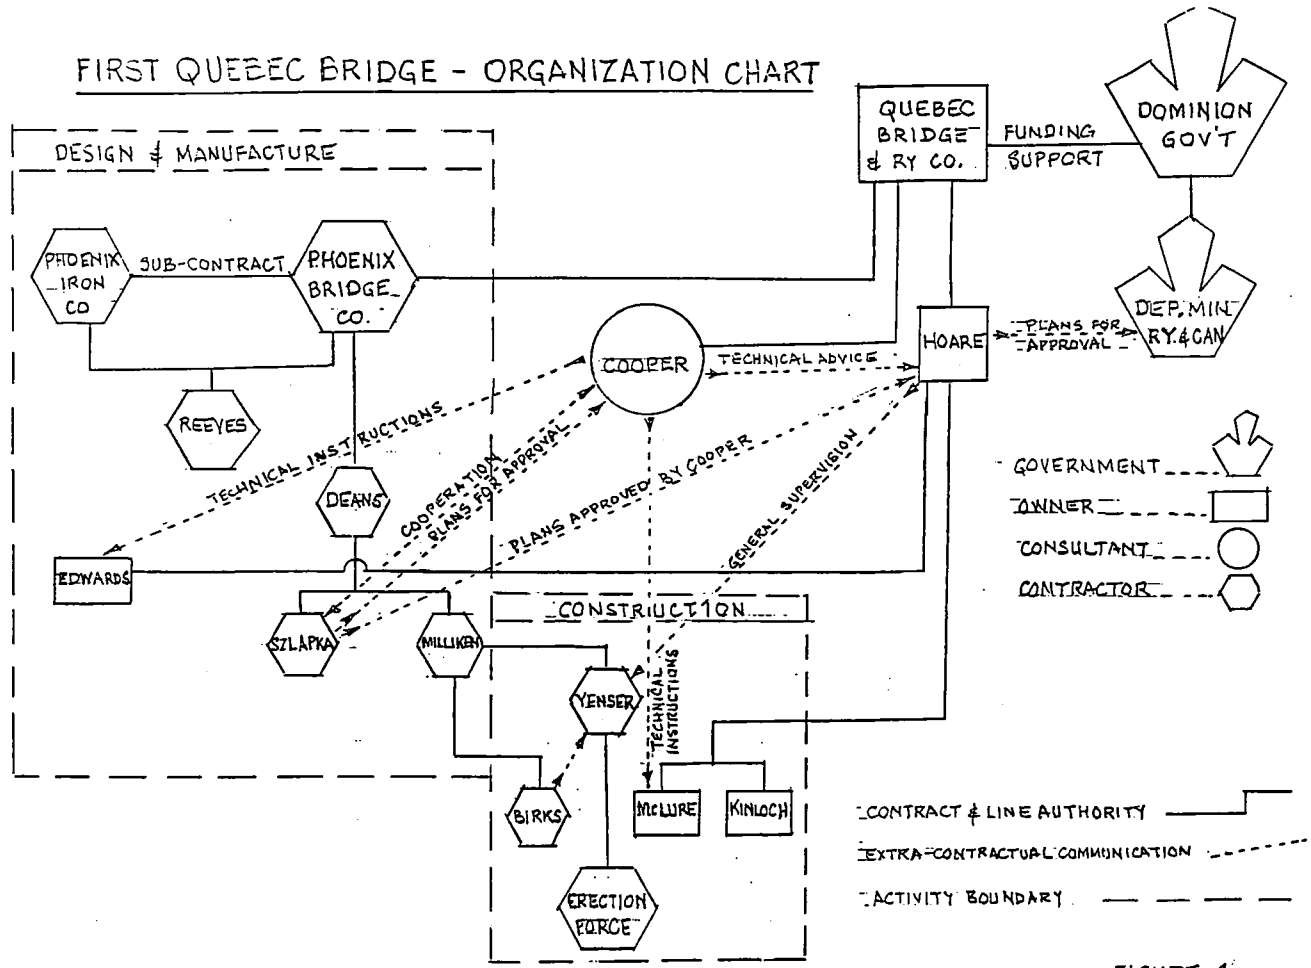
FIGURE 4

# FIRST QUEBEC BRIDGE - ORGANIZATION CHART

The organization which evolved to carry out the design and construction of the bridge is illustrated in the diagram on Figure 4.[11]. The Company's Chief Engineer, E.A. Hoare, was in principle the senior man on the whole project, responsible to the Company for final decision-making, at least in technical matters. But his lack of experience in major bridges led him to defer greatly to the Consulting Engineer, Cooper, who effectively assumed the reins of Chief Engineer.

The Organization Chart shows the formal procedure for approval of plans: Szlapka -> Cooper -> Szlapka -> Hoare -> Deputy Minister. In practice, as indicated in a table of dates at which various operations were performed,[12] when approved drawings were

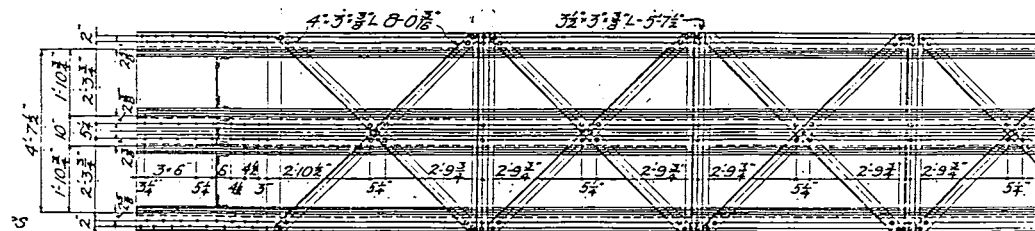
FIGURE 5

(a) FORTH BRIDGE COMPRESSION MEMBER - SECTION AND ELEVATION

(b) QUEBEC BRIDGE COMPRESSION MEMBER

We have now to consider the design of the compression members and in particular those of the lower chord, that part of the cantilever incorporating the distinct curve shown in Figure 2(b). As noted above, the strength of a compression member or strut depends principally on its resistance to buckling. In the case of the Forth bridge this was neatly accomplished by giving the members a cylindrical form, which during the erection stage involved the building up of the member curved plate by curved plate, a procedure well suited to the skills of Scottish shipwrights. But in North America the accepted practice was to use standard rolled steel sections (angles, flats, I-beams, etc.) in the fabrication of structural members. In the Quebec bridge the struts were built up from an array of parallel flat plates. Figure 5 shows a comparison of the compression members of the Forth and Quebec bridges. The bracing introduced for stiffening the latter may be clearly seen. The active cross-sectional area was about 800 square inches in Forth bridge and 842 square inches in the Quebec bridge.

The design of such members was at the time a mixture of theory and practice with empirical formulae playing an important part. In particular there was no rigorous way of determining the amount of latticing. These subjects were addressed at length in Appendix 16 of the QBI Report, which concluded:

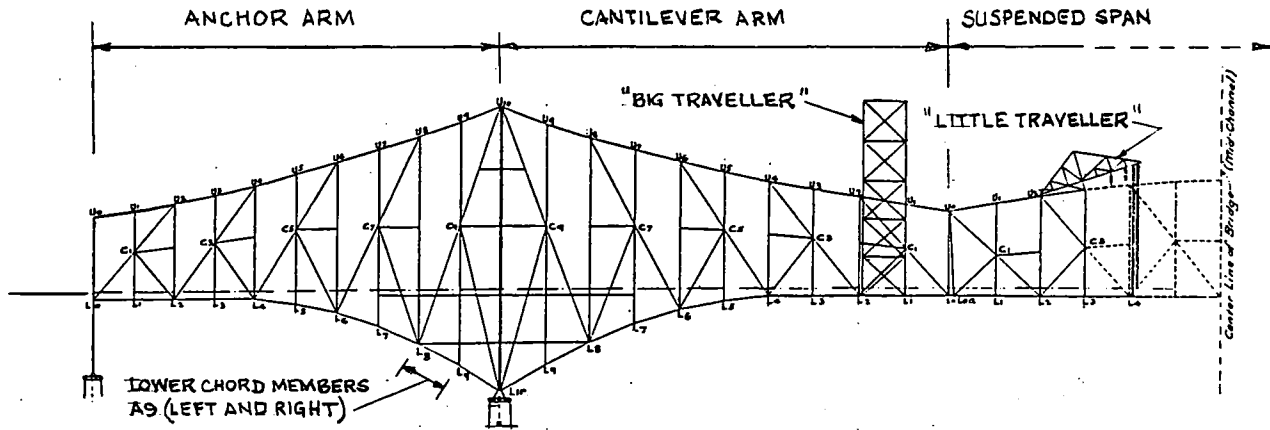
FIGURE 6

CONDITIONS ON AUGUST 29, 1907

By August, 1907, construction had reached the stage where the south cantilever had been completed and erection of the suspended span, jutting out from the end of the cantilever, was in hand. The 'big traveller,' a movable gantry used in the handling of components, was being dismantled in anticipation of transferring it to the north bank, and a 'little traveller' was in use for the work on the suspended span (see Figure 6).

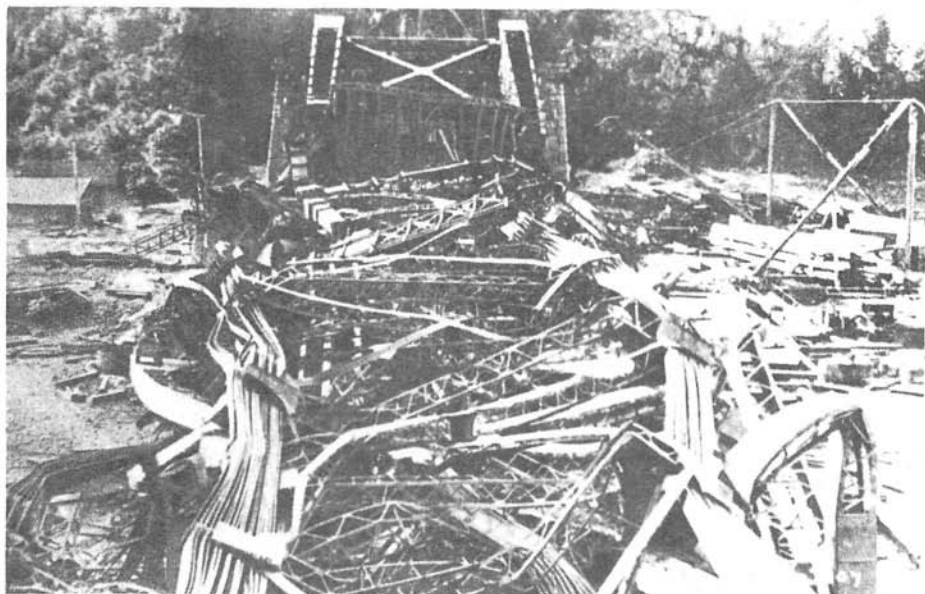
Figure 7(a) Wreckage, looking south [top]; 7(b) looking north

Cooper instructed McLure to discuss the problem with Deans. McLure's arrival in Phoenixville, at about 5.00 pm on Thursday, 29 August, coincided with the collapse into a tangled heap of the whole superstructure, taking the lives of 74 men, including Yenser and Birks. (Figures 7)
